## MARINE ACCIDENT BRIEF REPORT

**FIRE ON BOARD THE NETHERLANDS-  
REGISTERED PASSENGER SHIP  
*NIEUW AMSTERDAM*  
GLACIER BAY, ALASKA  
MAY 23, 2000**

**NTSB/MBR-01/01  
PB2001-916402  
Notation 7377  
Adopted July 24, 2001**

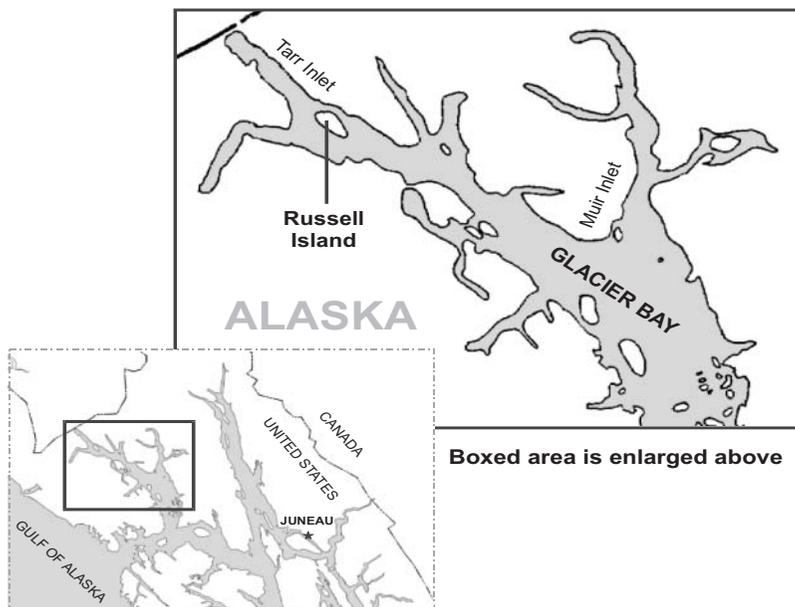
**Figure 1.** Approximate location of the *Nieuw Amsterdam* when the fire broke out.

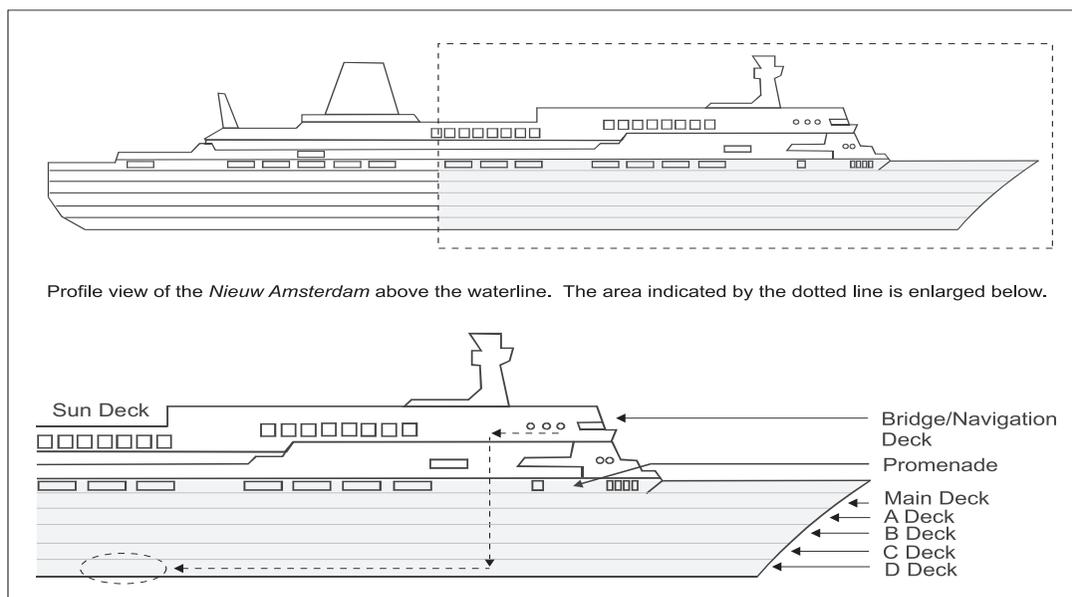
The quartermaster descended to D deck, eight decks below the navigation deck, and proceeded aft about 250 feet to the area where the smoke detector had activated. (See figure 2.) After passing fire screen door (FSD) D1, he observed smoke overhead and donned his smoke mask. (See figure 3.) Upon arriving at cabin D98, he saw smoke coming through the ventilation louvers in the lower section of the cabin door. He tried the door, but it was locked. He said that he immediately radioed a report of his observations to the third officer on the bridge, who, in turn, informed the master that smoke was coming from cabin D98.<sup>2</sup>

**Figure 2.** When the first alarm sounded on the fire detection system control panel, the third officer ordered a quartermaster who was on duty on the bridge to go to the affected area (indicated by the circle) to determine whether the alarm was false. The dotted line shows the route of the quartermaster from the bridge to cabin D98.

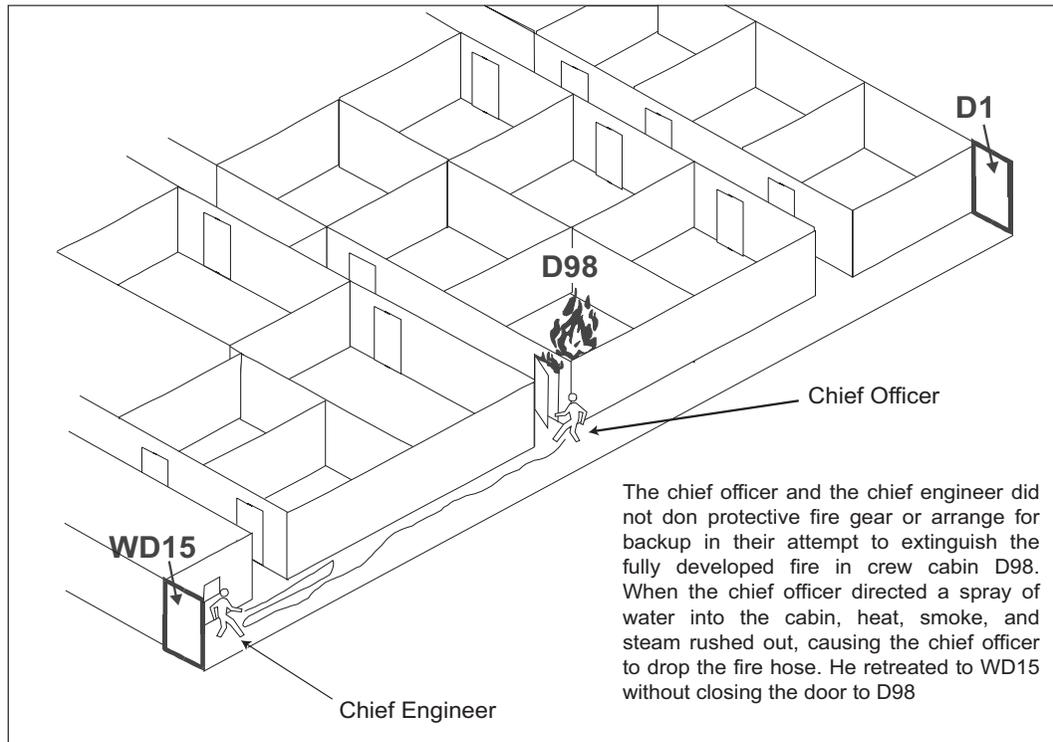
**Figure 4.** The attempt to extinguish the fire by the chief officer and the chief engineer.

closing the WTD behind them. Although the chief officer could not remember whether he had closed the door to cabin D98, subsequent events showed that he had not.

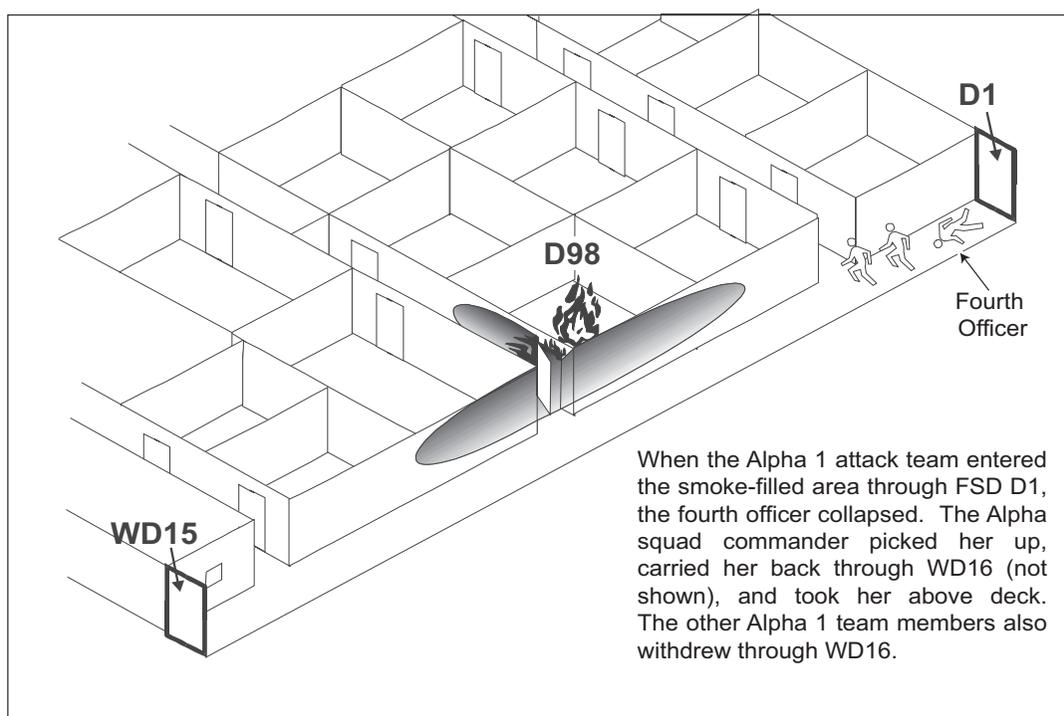
**Figure 5.** The Alpha 1 attack team's effort to fight the fire was abandoned when the team's leader, the fourth officer, collapsed.

About 0929, the Alpha 1 attack team and the Bravo 1 attack team both radioed the master that they were in position, forward of WD16 and aft of WD15, respectively. The master ordered the Alpha 1 team to attack the fire. The Alpha squad commander said that he opened WD16 and a lot of black smoke rushed out, reducing visibility to almost zero. The hose team advanced through FSD D1 into the passageway, giving shorts blasts of water to the overhead and bulkhead panels. (See figure 5.) The team leader (the fourth officer) followed the hose team. The squad commander indicated that because the team leader was new to the ship, he followed her to monitor her actions. When the attack team

members were a few feet into the passageway, the team leader collapsed,<sup>6</sup> and the squad commander picked her up and carried her back through WD16. The rest of the Alpha team followed, and they closed WD16 behind them. The squad commander then directed the squad assistant commander to take command of the hose team and stand by while he took the team leader to B deck. When the team leader appeared to be all right, the Alpha squad commander later returned to D deck.

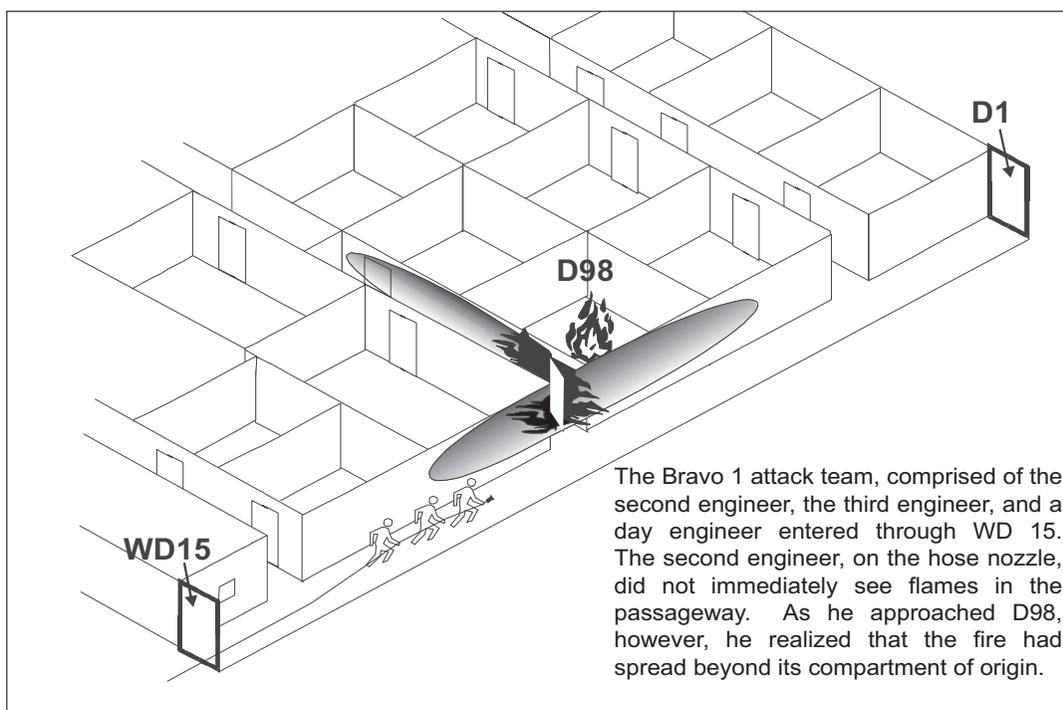
At 0930, upon overhearing radio communications between the Alpha squad and the bridge, the Bravo 1 attack team radioed the bridge that it was entering the area through WD15. The second engineer said that he took the fire hose nozzle and led the attack. He had the day engineer serve as backup on the hose and the third engineer follow with a flashlight and a UHF radio. (See figure 6.)

**Figure 6.** Upon hearing that the Alpha 1 attack team had withdrawn, the backup unit, in this case the Bravo 1 attack team, entered the area to fight the fire.

The Bravo 1 attack team members entered the passageway on their knees. The second engineer said that the main passageway was filled with thick black smoke but had a light draft of air moving through it. He said that when he sprayed the overhead, he saw burned paint hanging down but no flames. He did not see any flames in the passageway;

As the Bravo 1 attack team approached cabin D98, the second engineer realized that the fire had progressed outside the cabin of origin. He said that he felt an increase in temperature and could see flames on the deck in the main passageway and in a portside corridor. He found the door to D98 open and saw flames inside the cabin. He said that, while approaching cabin D98, he was spraying water in the main and other passageways when he discovered that the hose line from the boiler room would reach no farther. He retrieved the charged hose line that the chief officer had abandoned and resumed spraying the decks and overheads. He then attacked the fire inside cabin D98. He said that after he sprayed water into the cabin for several minutes, the flames were no longer visible.
